<b>Inspection Report</b> ( <input checked="" type="checkbox"/> 1 <sup>ST</sup> <input type="checkbox"/> 2 <sup>ND</sup> )		<h1 style="margin: 0;">PENDING</h1>
<input checked="" type="checkbox"/> Pre-shipment <input type="checkbox"/> ON-LINE <input type="checkbox"/> IN PROCESS <input type="checkbox"/> FULL		
<b>Summary Section</b>		Service Number: F-QC 20140816060107

Product Name	Garment steamer
	Item number	HDG602B
	P/O number	---
	Quantity	595pcs
	Client name	---
	Supplier name	---
	Inspection date	2014-08-16
	Arrival time	8:00AM
	Departure time	14:00PM
	Inspection location	Cixi, Zhejiang, China
	Inspector	KEVIN

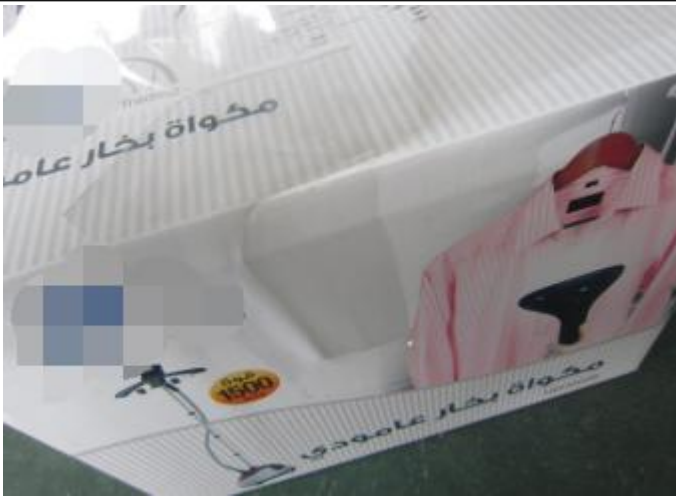
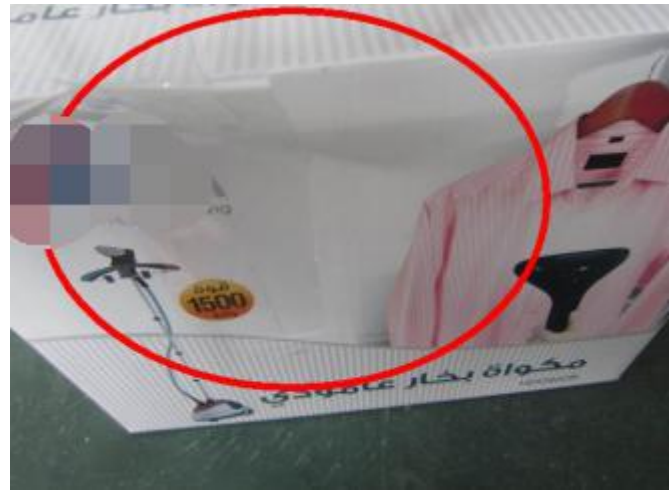
<b>Special Attention</b>	
1> No approved sample and approved specification for reference, please check the actual finding. 2> The gift box was sealed with scotch tap, the cover film of the color box will be damaged when open the product and tear the scotch.

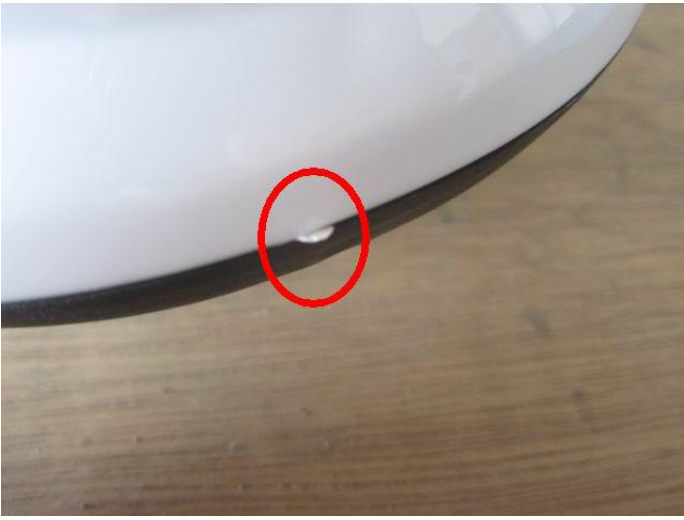
Defectives List				
Defectives Description		CRI	MAJ	MIN
1.	Flash	0	1	0
2.	Dirty mark	0	0	3

Flash	Dirty mark
